# National Highways 'Structures Moonshot'

# Post Tensioned Structure Investigation – Current state of the art and Problem Statement

# Huntingdon Viaduct Trials: Hydrodemolition and Inspection

# Huntingdon Viaduct Trials: Inspection Findings

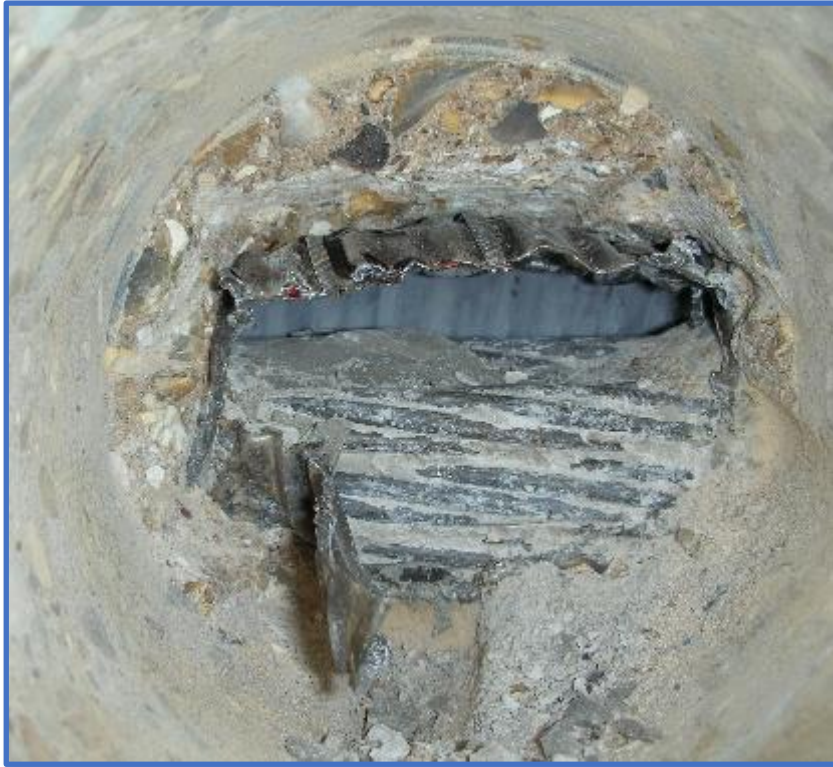
Lack of grout in post-tensioning duct

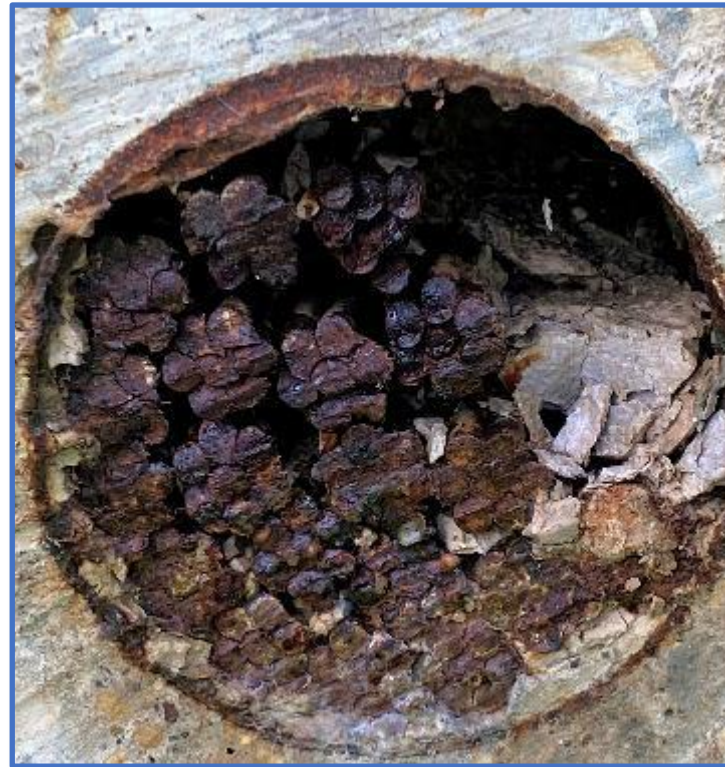
Corroded strands in a poorly grouted duct

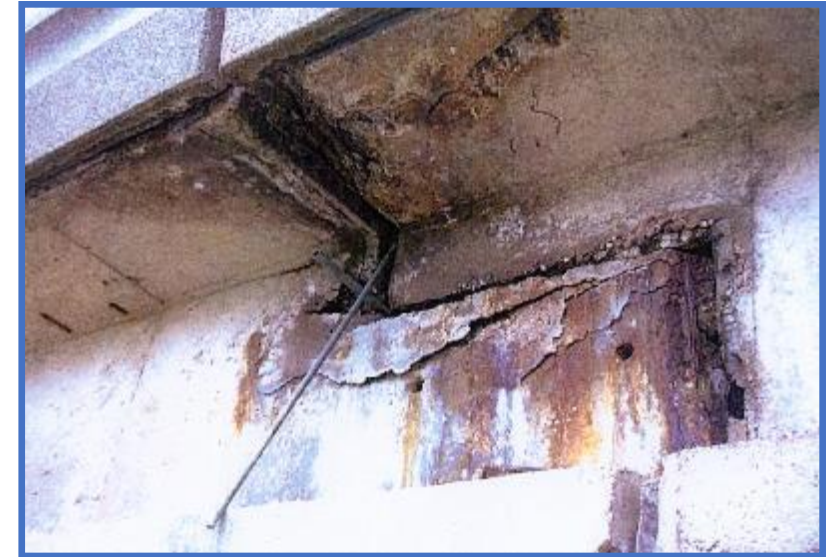
Half-joint
