Bridge rehabilitation: meeting evolving safety, performance and durability demands for aging infrastructure

Amol Singh Technical Project Manager

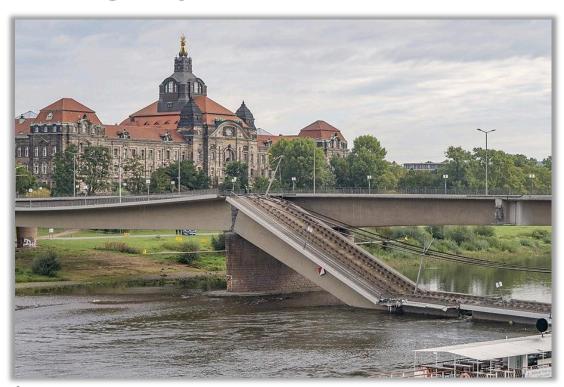
The recent Carola Bridge collapse in Dresden reiterates the urgency required to take preventative actions

- Built originally in 1895, rebuilt in 1967-71
- First renovated in 1996
- Widened in 2019 to accommodate additional bicycle lanes
- Was marked for strengthening in 2025
- Collapsed Sep 2024
- Main cause identified: hydrogeninduced corrosion cracking of the reinforcement, undetected despite regular inspections.

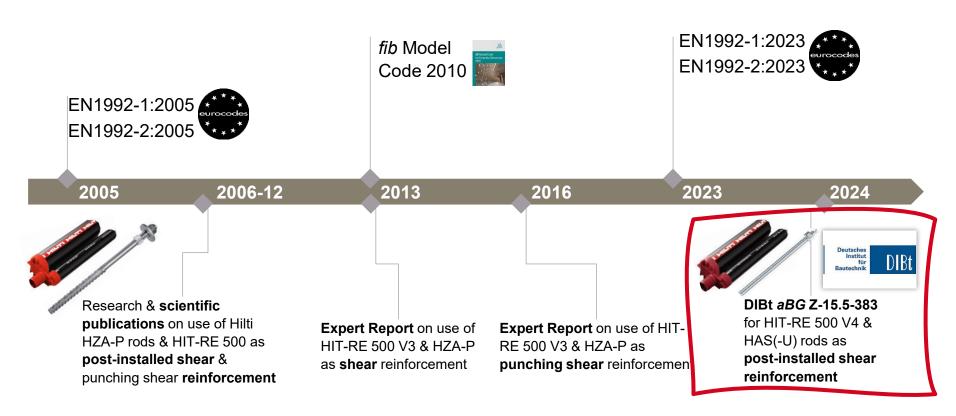
Over 20 years of developing the use of post-installed rods as shear reinforcement

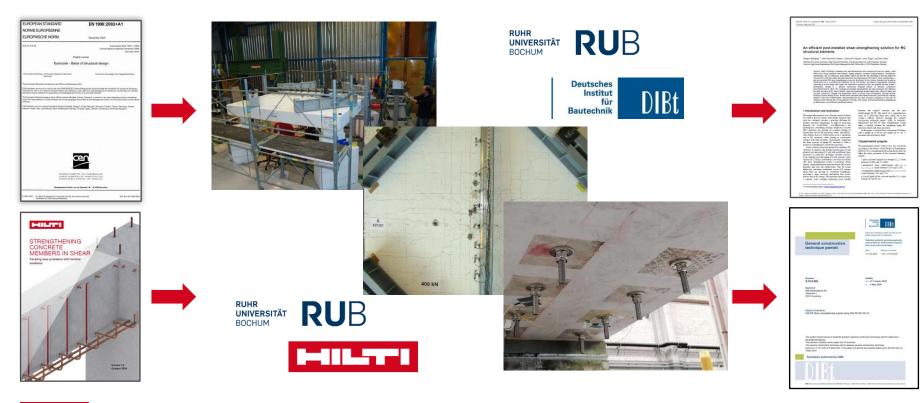
Post-installed shear reinforcement system is proven to work similar to traditional cast-in shear links

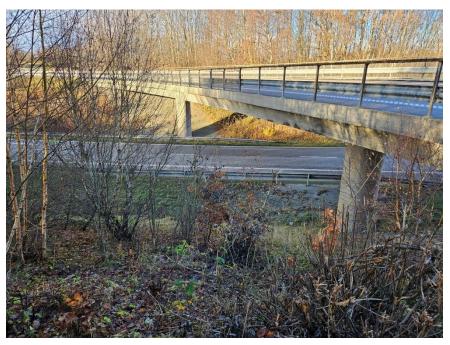
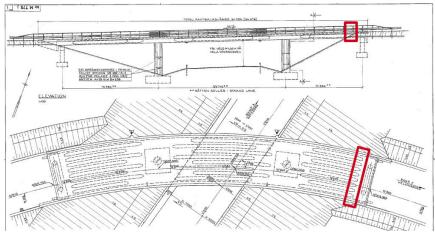
Bridge strengthening: pilot project with Swedish Transport Agency with HIT-Shear system

- 3-span continuous plate highway bridge with hollow sections of a total length of 58 m.
- The need for shear strengthening is limited to an area in the shortest span close to the very right support.

5 pcs **HAS-U A4 M20 + HIT-RE 500 V4 + Filling set** with effective depth 890 mm in 9 rows = 45 pcsof post-installed reinforcement elements ensure that the bridge has a shear capacity.

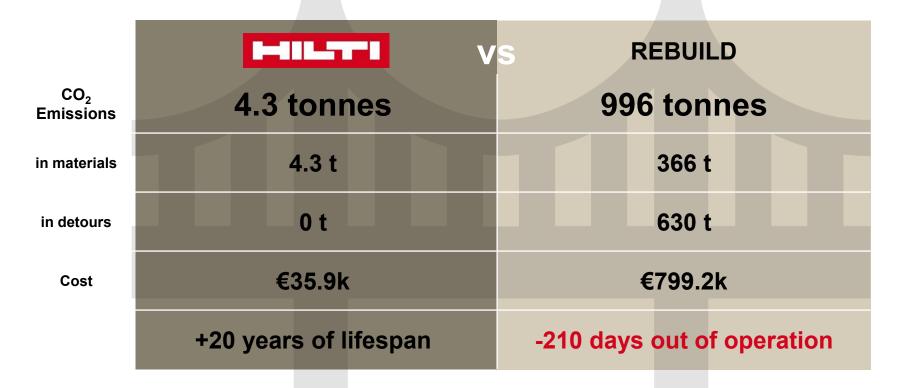
Strengthening reduces the carbon footprint and construction cost by over 97%
