# National Highways 'Structures Moonshot'

# Post Tensioned Structure Investigation – Current state of the art and Problem Statement

# Huntingdon Viaduct Trials: Hydrodemolition and Inspection

# Huntingdon Viaduct Trials: Inspection Findings

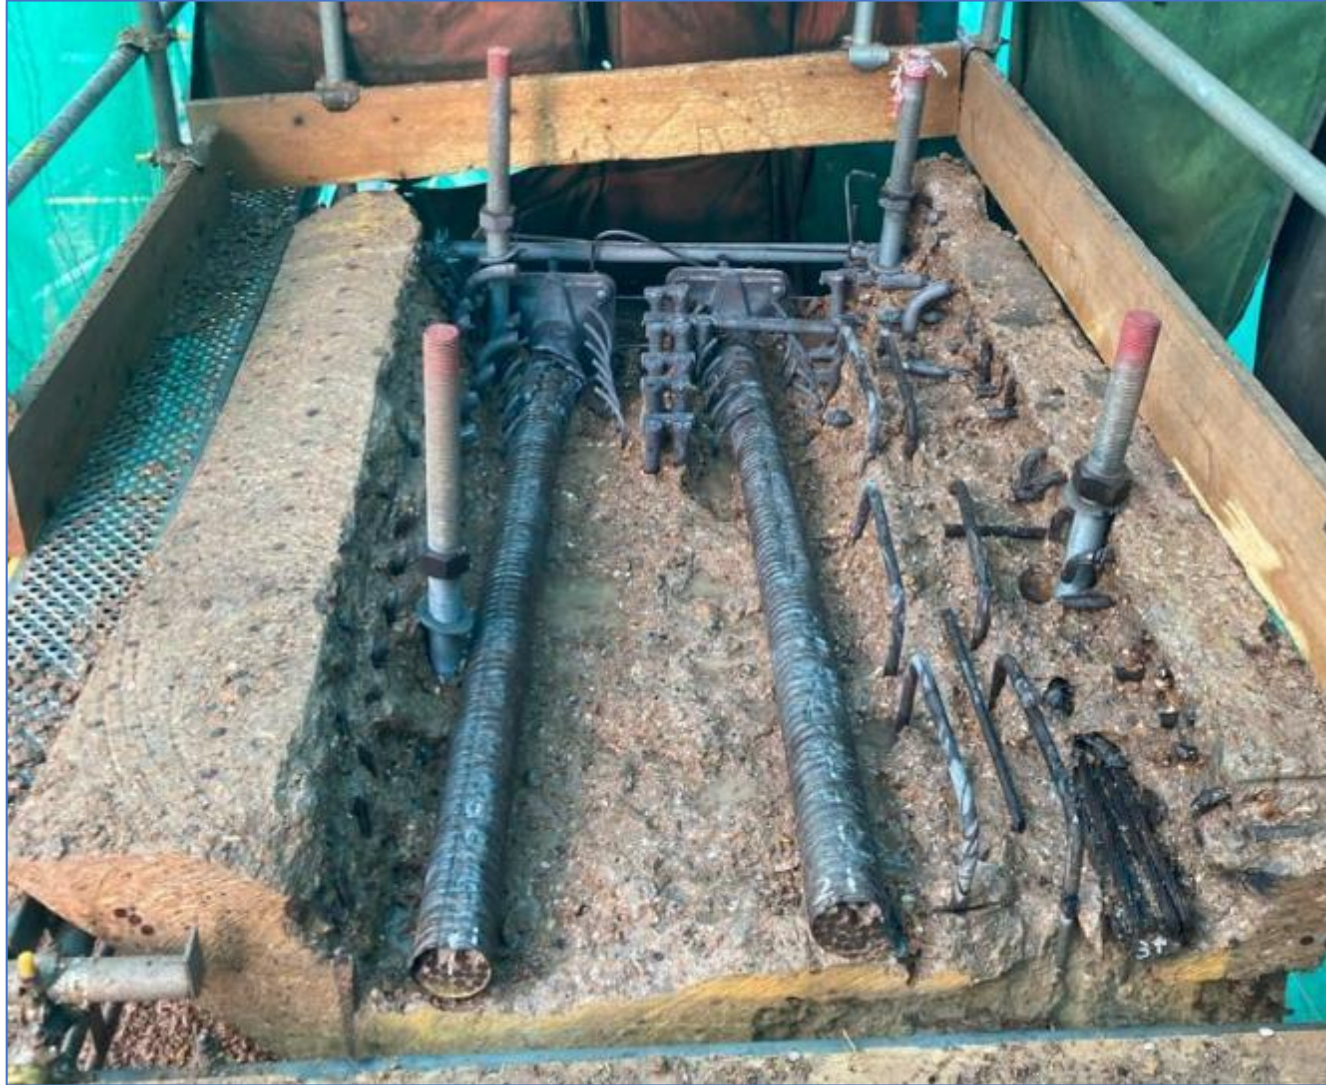
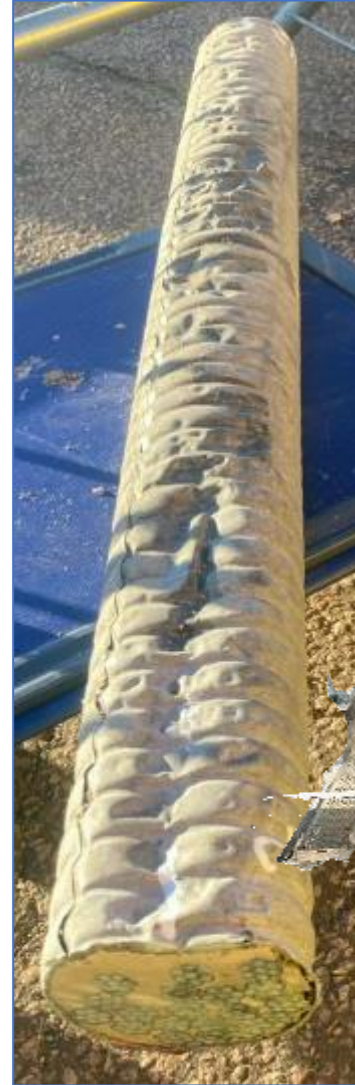
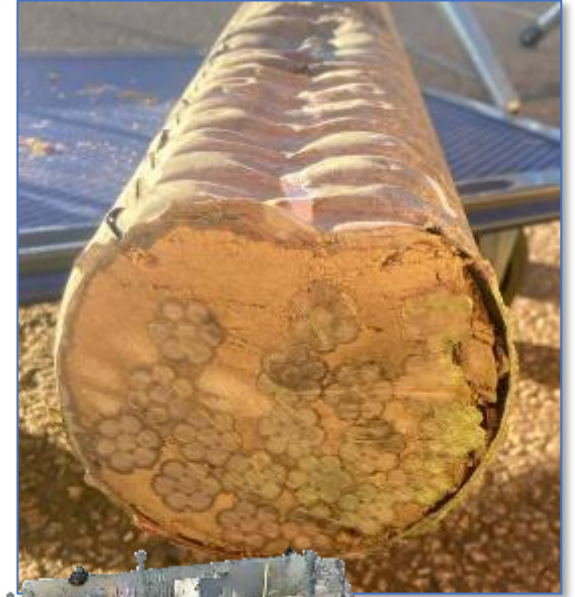
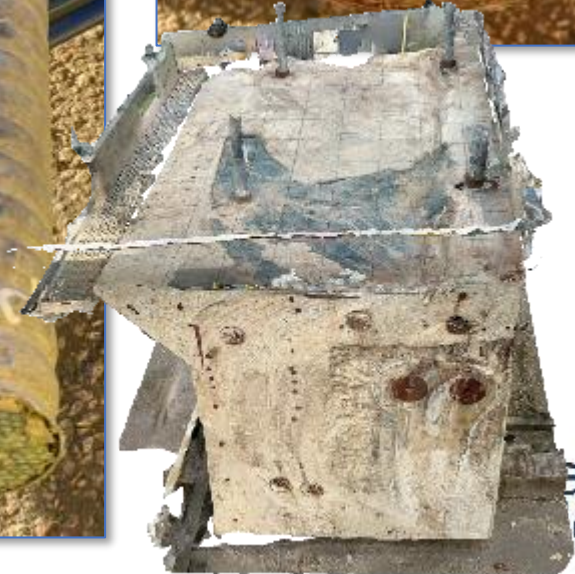
# Hydrodemolition Findings – Sample 1

Opening Order	Sample	Tendon	Chainage			Date Opened in lab	General Strand / Wire Observations
3	1	1	0	-	1	29/03/2024	Significant voiding of the grout evident, light surface corrosion of wires
	1	1	1	-	1.5	03/04/2024	Grout OK, white / powdery, Light surface corrosion
	1	2	0	-	1	07/04/2024	Grout voiding at 12'O clock position, Strands and wires all in average condition - surface corrosion
	1	3	0	-	1.7	07/04/2024	Tendon in very poor overall condition, strands cut (cored) / corroded wires in evidence
6	3	1	0	-	1.7	24/04/2024	Grout voiding at 12'O clock position, Strands and wires all in average condition - surface corrosion
	3	1	1.7	-	3.2	24/04/2024	Grout voiding at 12'O clock position, Strands and wires all in average condition - surface corrosion
	3	1	3.2	-	4.7	11/04/2024	Grout intact throughout and at ends, Strands and wires all in good condition
	3	1	4.7	-	6.15	11/04/2024	Grout intact throughout and at ends, Strands and wires all in good condition

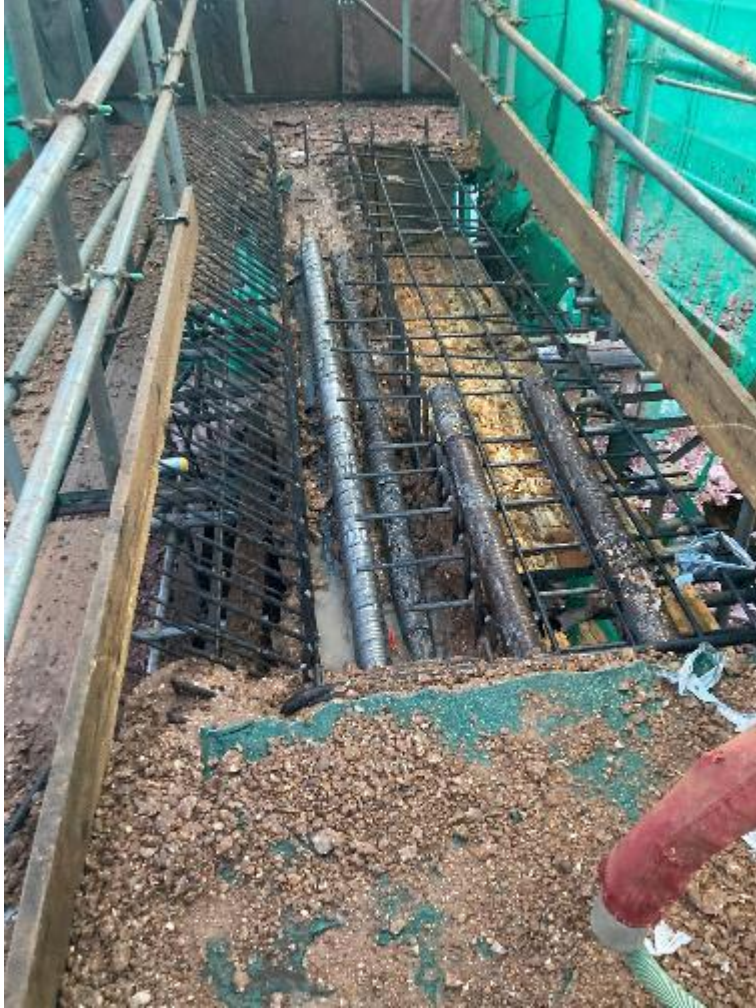
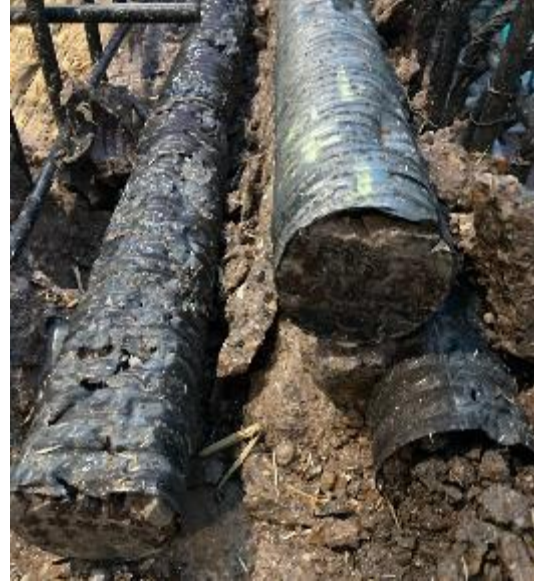
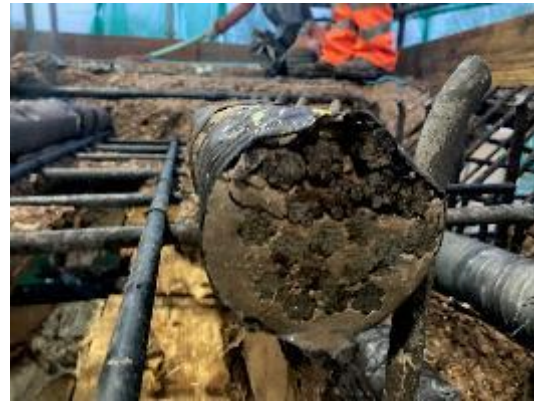
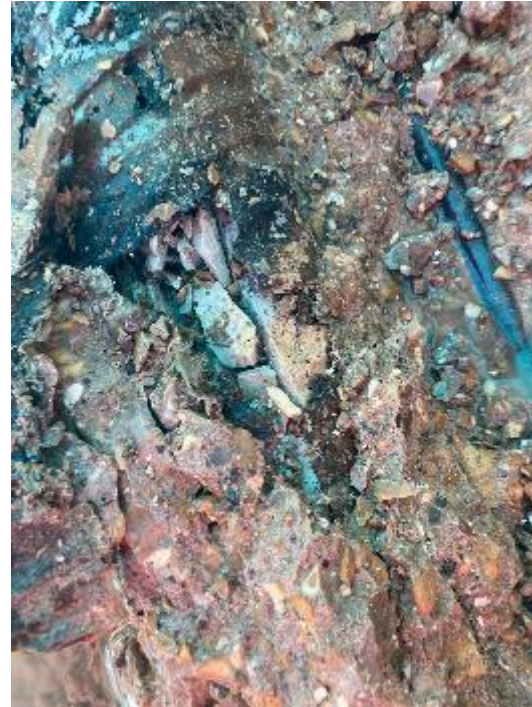
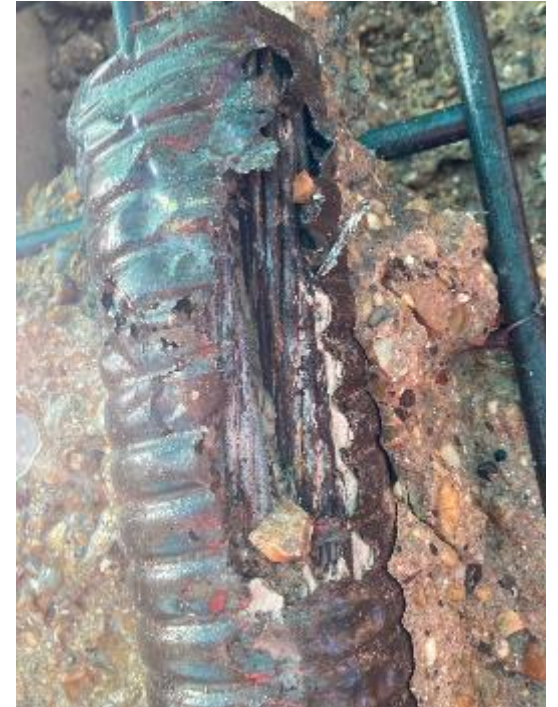
# Hydrodemolition Findings – Sample 3

7	3	2	0	-	1.7	25/04/2024	Grout segregation / bleeding (sands) at 12'O clock position, Strands and wires all in good condition
	3	2	1.7	-	3.4	25/04/2024	Grout segregation / bleeding (sands) at 12'O clock position, Strands and wires all in good condition
	3	2	3.4	-	4.6	17/04/2024	Grout intact @3400 end, loose at 4600 end, Strands and wires all in good condition
	3	2	4.6	-	6.2	17/04/2024	Poor grout, no significant corrosion except local to 6200 end with minor section loss to wires. Aligns with where minor loss of grout also observed
8	3	3	0	-	1.7	26/04/2024	Grout segregation / bleeding (sands) at 12'O clock position, Strands and wires in poor condition (section loss and corrosion)
	3	3	1.7	-	3.4	26/04/2024	Grout segregation / bleeding (sands) at 12'O clock position, Strands and wires in poor condition (section loss and corrosion)
	3	3	3.4	-	4.7	02/05/2024	Grout segregation / bleeding (sands) at 12'O clock position, Strands and wires all in average condition (surface corrosion)

3	3	4.7	-	6.2	02/05/2024	Grout segregation / bleeding (sands) at 12'O clock position, Strands and wires all in average condition (surface corrosion)
5	3	4	0	-	1.7	04/04/2024	Poor grout, no significant corrosion / pitting to wires observed
	3	4	1.7	-	3.3	07/04/2024	Grout intact throughout and at ends, Strands and wires all in good condition
	3	4	3.3	-	4.8	07/04/2024	Grout intact throughout and at ends, Strands and wires all in good condition
	3	4	4.8	-	6.2	07/04/2024	Grout intact throughout and at ends, Strands and wires all in good condition
2	3	5	0	-	1.7	27/03/2024	Minimal grout, One wire break ST.17
	3	5	1.7	-	3.2	02/04/2024	Minimal grout, some wire pitting
	3	5	3.2	-	4.7	02/04/2024	Grout over half length of duct, duct steel poor, surface corrosion to wires
	3	5	4.7	-	6.25	03/04/2024	Grout intact throughout and at ends, Strands and wires all in good condition
4	3	6	0	-	1.6	03/04/2024	Tendon in very poor overall condition, strands and broken / corroded wires in evidence

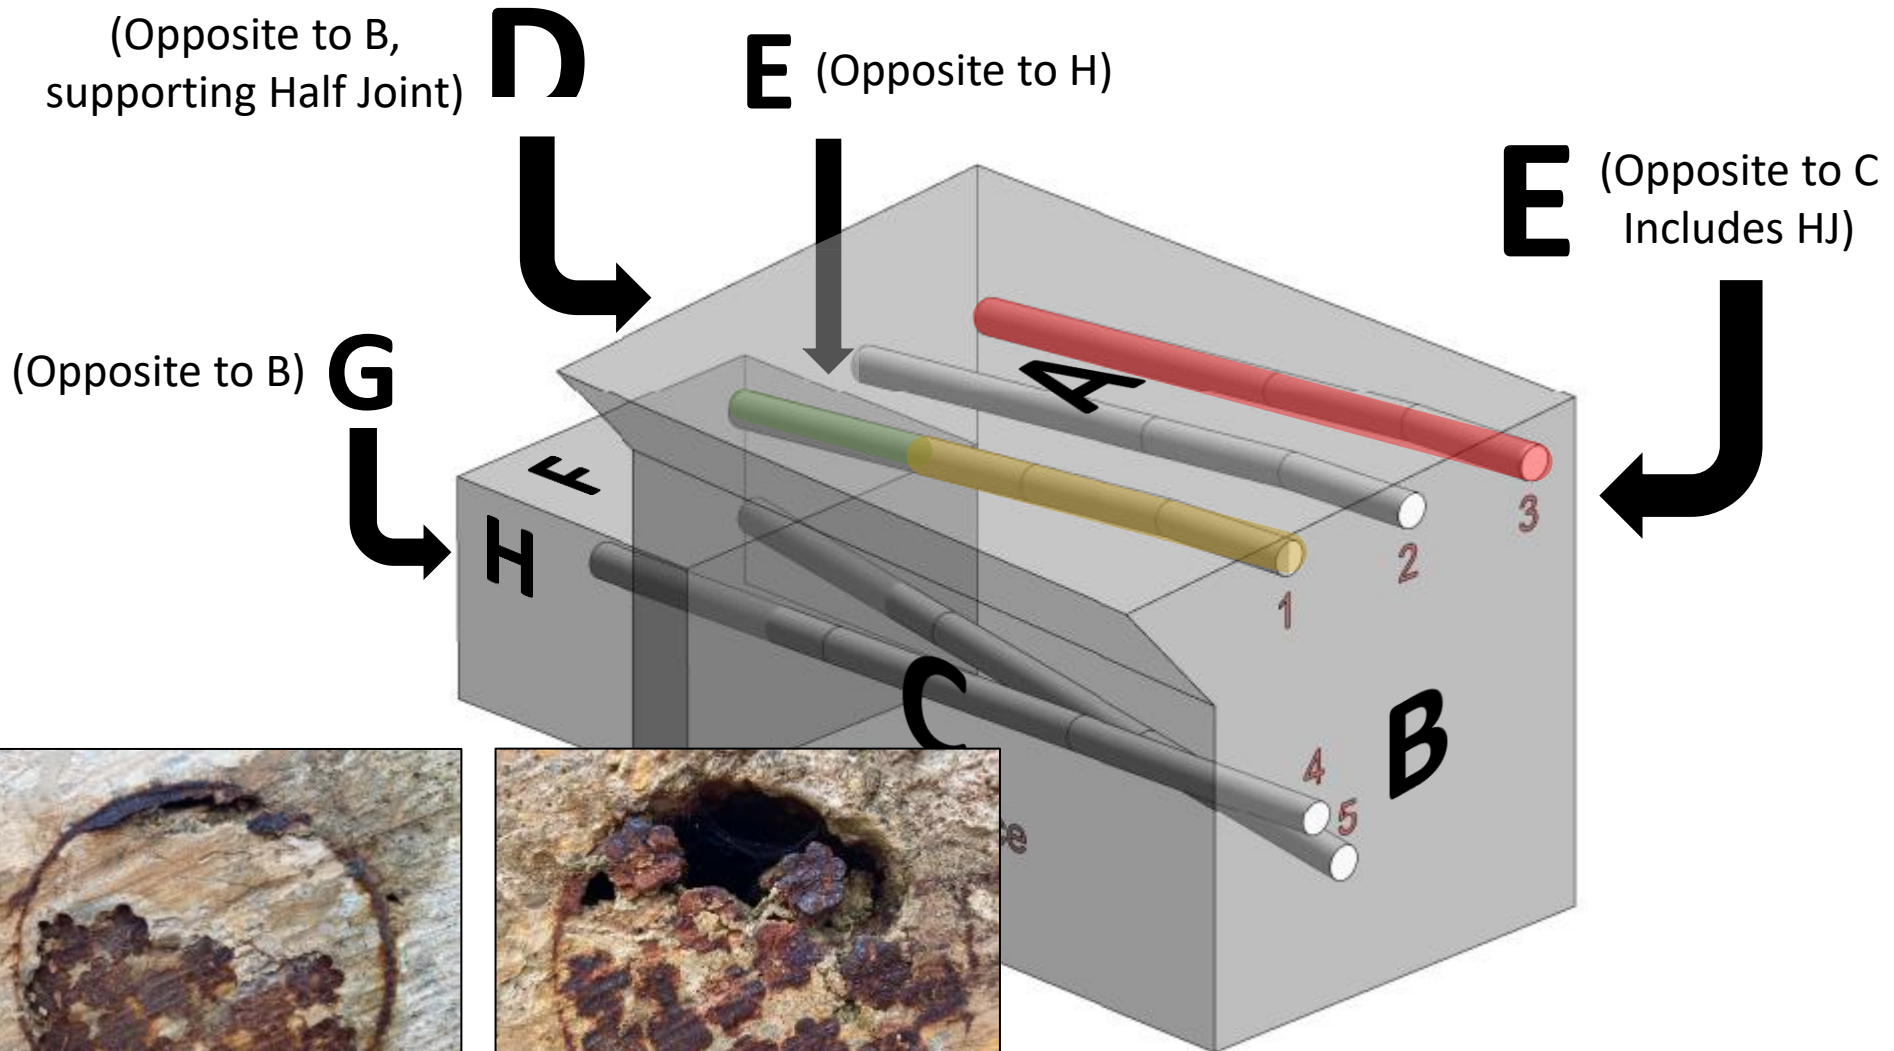
# Sample 1

1	3	7	0	-	1.6	21/03/2024	Grout largely intact - different materials - minor pitting to wires noted
	3	7	1.6	-	3.2	22/03/2024	Grout largely intact - different materials - minor pitting to wires noted
	3	7	3.2	-	4.8	22/03/2024	Grout largely intact - different materials - surface corrosion to wires noted
	3	7	4.8	-	6.07	27/03/2024	Grout largely intact - different materials - surface corrosion to wires noted
